Historical Case Studies of Extreme Events

East Coast Lows and the Newcastle/Central Coast Pasha Bulker Storm

Published by the National Climate Change Adaptation Research Facility 2010

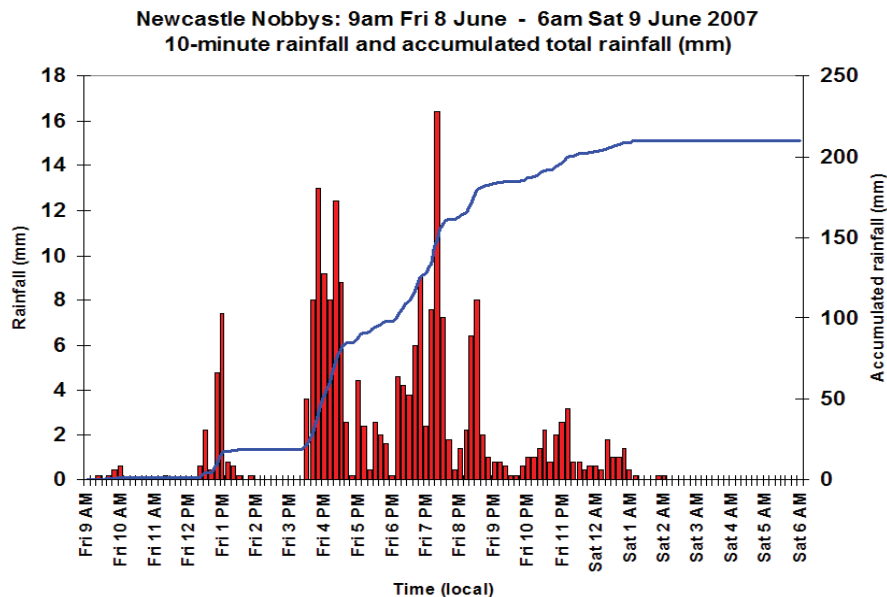
Heavy rainfalls were received between the June 7-10 across the Newcastle, Central Coast and the Hunter regions, with over 400 mm of rainfall received at some locations (more than twice the average monthly totals for June). The peak in rainfall occurred for most regions on the 8th and 9th of June when Newcastle (Nobbys Signal Station) recorded 164.8 mm in 6 hours (Figure 5). Newcastle University and BMT WBM Pty Ltd analysed data from a network of 30 pluviographs throughout the Hunter region to assess the meteorological significance of the event [Haines and Thyer, 2008]. There was a high degree of variability among the pluviographs, however at some locations the measured rainfall for 3, 6, 12 and 24 hour durations had a recurrence interval in excess of 100 years. It is important to note however that these recurrence intervals are estimated using short data sets which may not capture the true rainfall distribution.

Figure 5 Newcastle 10-minute rainfall on 8th and 9th of June 2007 measured at Nobby's signal station (source: www.bom.gov.au)

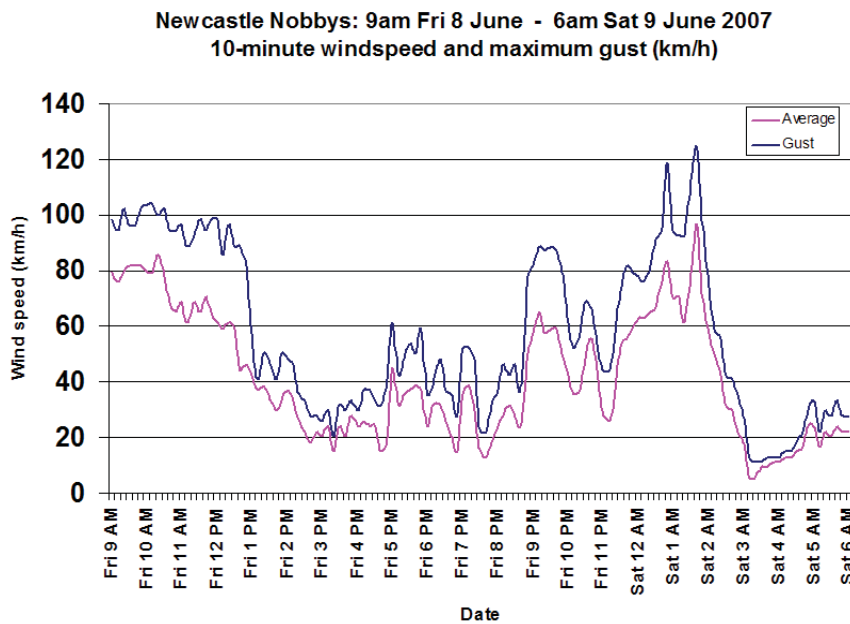
Gale force winds were sustained for approximately 20 hours from 6am on the 8th June through to 2am on the 9th June [Carpenter, 2007]. The maximum windgust speed recorded was 135 km/hr at Norah Head, followed by 125 km/hr at Nobbys Head (Figure 6). While a significant event, wind speed records were not broken during this ECL [Carpenter, 2007].

Figure 6 Newcastle 10-minute windspeed 8-9 June 2007 recorded at Nobbys' Signal Station (Source: Bureau of Meteorology)

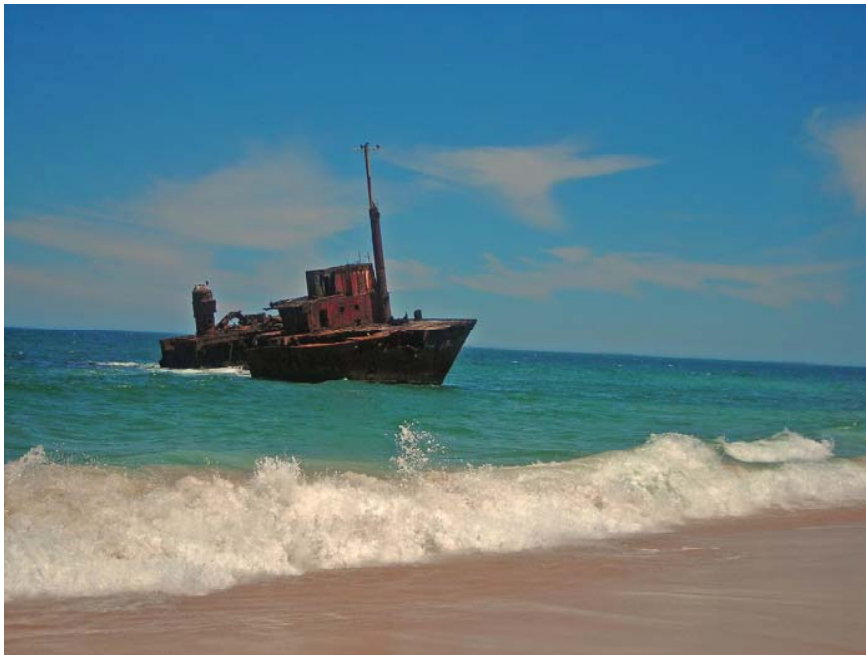
Figure 8 Wreck of the Sygna ship on Stockton Bight as it looks in 2009. Photo: Lee Stone.

The June 2007 storms have often been compared to the May 1974 storms, which also resulted in widespread devastation along the coast of NSW. The May 1974 ECL was concentrated between Illawarra and the Hunter and also claimed a bulk carrier ship (the Sygna) which ran aground on Stockton Bight (Figure 8), just north of Nobby's beach where the Pasha Bulker was grounded. The 'Sygna storm', as it became known, produced much stronger windgusts (170 km/hr) than the Pasha Bulker storm. However, the Sygna storm had a much shorter duration and less rainfall recorded (maximum 24-hour rainfall was 194 mm at Pambula). The storm event was determined to have a corresponding wave height recurrence interval in the order of 20-70 years [Watson *et al.*, 2007] and the Newcastle port reported a swell of over 17 metres at the entrance. The water level encountered during the May 1974 storm was 53cm higher than Pasha Bulker storm (2.37 m) in Sydney Harbour – the highest level since records commenced over 100 years ago [Watson *et al.*, 2007]. The ECLs of May 1974 also had a greater impact on coastal erosion than those ECLs experienced in 2007, due to larger off shore wave heights.

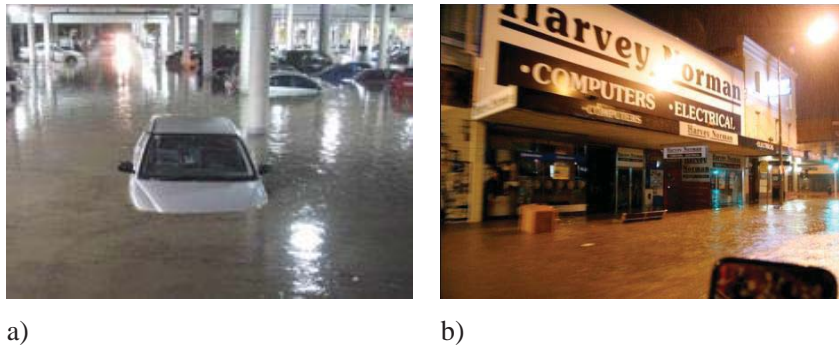
were written off, while more than 90,000 claims have been filed with insurance companies [Carpenter, 2007]. An estimated 10,000 properties were inundated across the Newcastle LGA, which typically included yards, garages, and outside buildings (Figure 9 a&b). Of these, some 1000 to 2000 properties experienced over-floor flooding. The commercial district of Wallsend had flooding of up to 1.5 m over the floors, while many residential areas (e.g. Hamilton North) had over-floor flooding of greater than 0.8 m. Many thousands of properties reported flood waters reaching just below their floors.

Figure 9 Urban flooding during the event a) Westfield car park, Kotara, b) Hunter Street, Newcastle CBD.

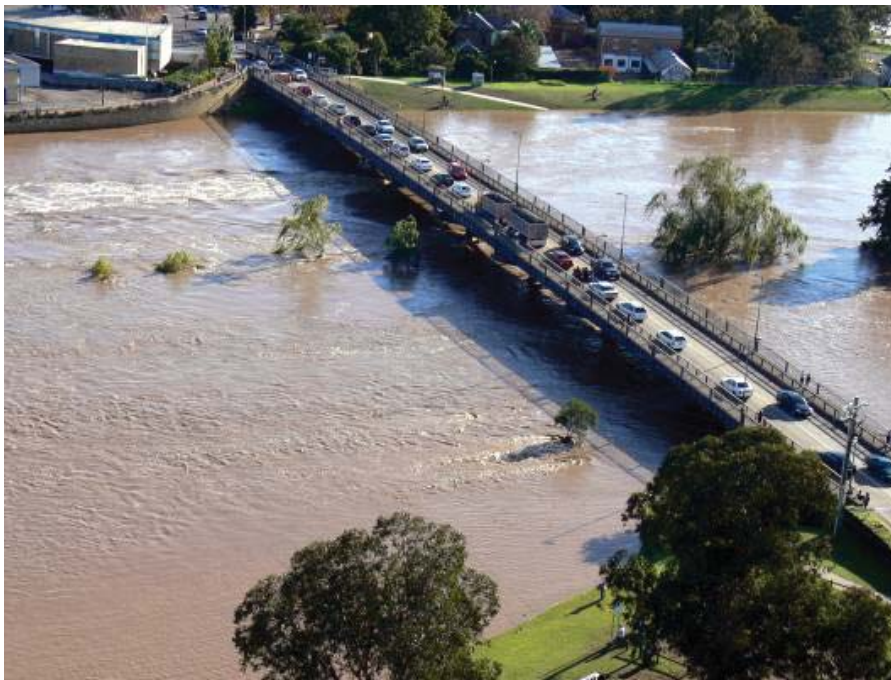
The rainfall from 8-11 June 2007 in the Hunter catchment produced the second highest flood peak event at Belmore Bridge (Figure 11) at Maitland since the devastating February 1955 flood [Webb, 2008]. Approximately 5000 people were evacuated from their homes in Maitland on 11 June, with the SES expecting the nearby Hunter River to break its levee banks and flood populated areas. However the river peaked at 10.7 m, not high enough to break the levee banks and residents were quickly allowed to return home. Section 6.1 provides more details on the flooding of the Hunter River and an analysis of the performance of the Maitland Hunter River Flood Protection System.

Figure 11 The Belmore Bridge at Maitland spanning the flooded Hunter River. Photo taken 2:30pm 11 June 2007 (Source: Image courtesy of SES NSW)

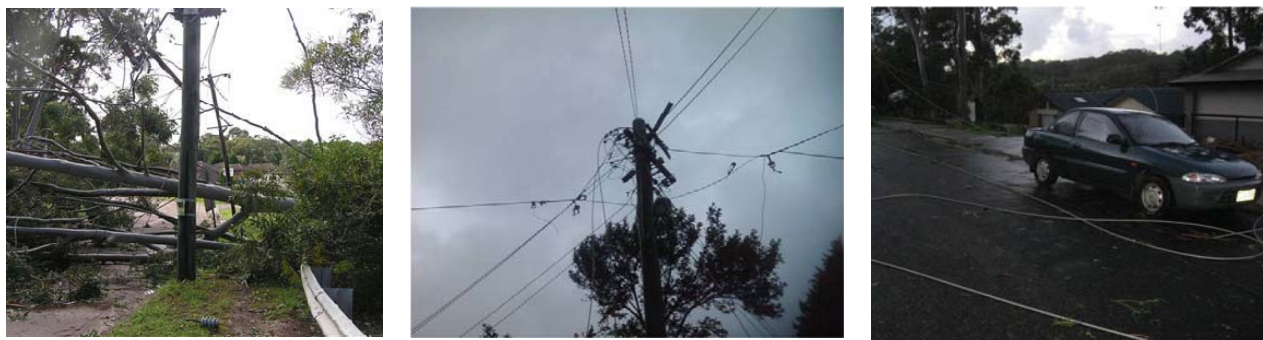
The storm caused unprecedented and widespread damage to Energy Australia's power supply network (Figure 12). Wind gusts of more than 120 km/hr uprooted trees, damaging power lines and some power lines were also washed away in the resulting flood waters. Tree throw was higher than expected because of significant rainfall preceding the storm so that soils were already saturated reducing tree root stability. Around 100,000 homes and businesses from the Hunter to the northern suburbs of Sydney were without power on 8 June. By Saturday morning, that number doubled to a peak of 200,000 homes without power. In the Hunter, one in three of Energy Australia's customers was without power in the region. At times Energy Australia's call centre was taking, on average, 1000 calls every half an hour. In the 24 hour period from midnight Friday, 8 June to midnight Saturday, 9 June, more than 93,000 calls were received, the highest number of calls ever received by the call centre.

Figure 12 Damage caused to power lines during the storm. Source: Images courtesy of Energy Australia).

The power restoration process was the biggest undertaken in the Energy Australia's history. Energy Australia's first priority was to make areas safe, repair isolated sections of power lines and restore supply where possible. This required mobilisation of all available Energy Australia staff, with additional resources provided from eight power companies across New South Wales, Queensland, Victoria and the ACT. More than 1500 electricity workers (including 300 from interstate and across NSW) worked to rebuild the electricity network and restore power to customers progressively over seven days. Energy Australia line workers, inspectors and emergency service technicians were called to make up crews to patrol lines, make fallen lines safe where possible, report locations of damaged sections of the network, and switch back on any healthy parts of the network. Support staff also worked continuously as part of the restoration effort.

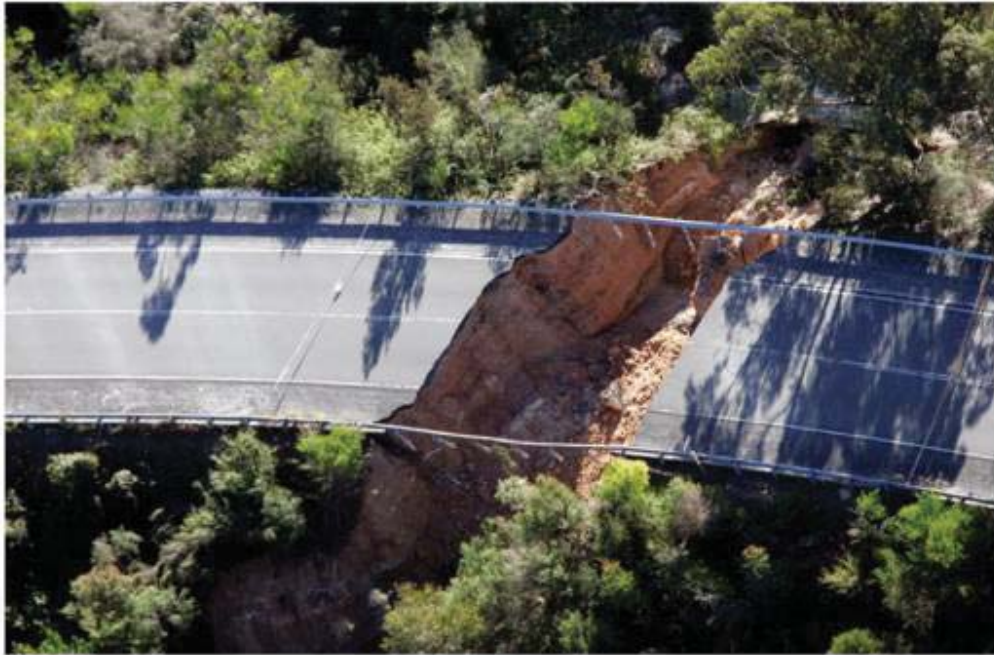
A section of the Old Pacific Highway near Somersby collapsed at a culvert on 8 June after heavy rain (Figure 13), taking with it a car travelling with five passengers. A subsequent investigation into the collapse has revealed that warnings regarding the deterioration of the road and culvert dated back to 1984. In 2000, the road at the culvert had slumped, and the "mechanisms of collapse" were already in operation (Sydney Morning Herald, 1/7/2008).

Figure 13 Collapse of Pacific Highway, Somersby Central Coast (source: ABC TV)

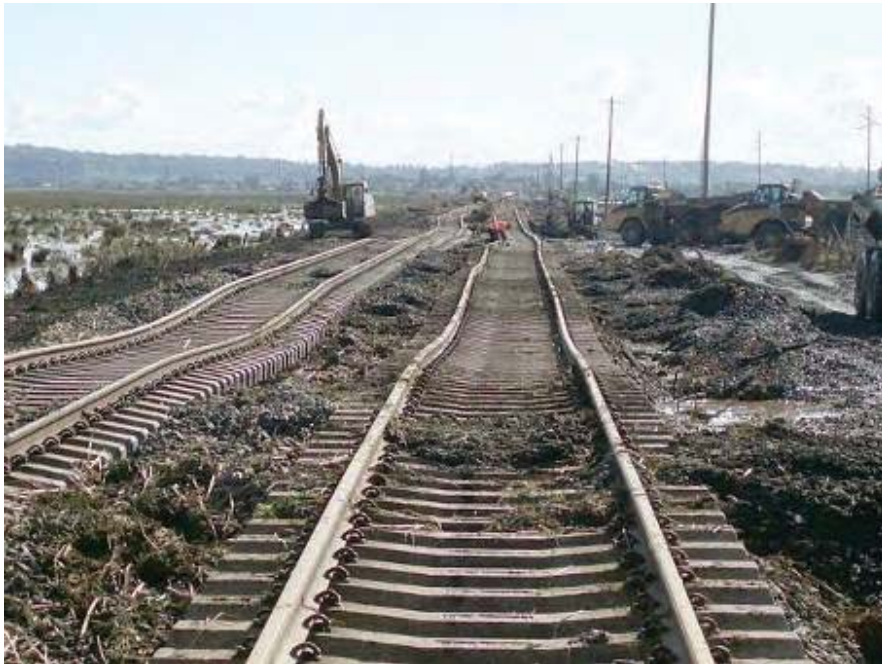
The rail network was disrupted with several sections damaged or cut-off by floodwaters or fallen debris (Figure 14). The main north coast rail line was cut at Wondabyne due to storm water discharging through the sandstone quarry causing a landslide [Watson *et al.*, 2007]. A commuter train also became trapped between stations, due to flooding, and all travellers were evacuated to Hornsby. Train services over the Australian Rail Track Corporation (ARTC) Hunter Valley rail network were severely disrupted as a result of the storms. Major problems occurred in the section between Singleton and Whittingham where both tracks were heavily undermined by flood-waters [Australian Rail Track Corporation 2007]. At Minimbah and Belford the structural integrity of the

embankments was affected, the flood protection gates at Maitland forced the closure of the track and at Sandgate the switches were affected by flood-waters. ARTC crews worked to reopen affected rail services and were able to begin re-operating in eight days, while full pre-storm track capacity was restored within two weeks. The cost of repairs to Hunter Valley rail network from the storms and flooding was estimated at around AUD4 million.

Figure 14 Damage to the rail lines as a result of the heavy rainfall and subsequent erosion (source: Australian Rail Track Corporation)

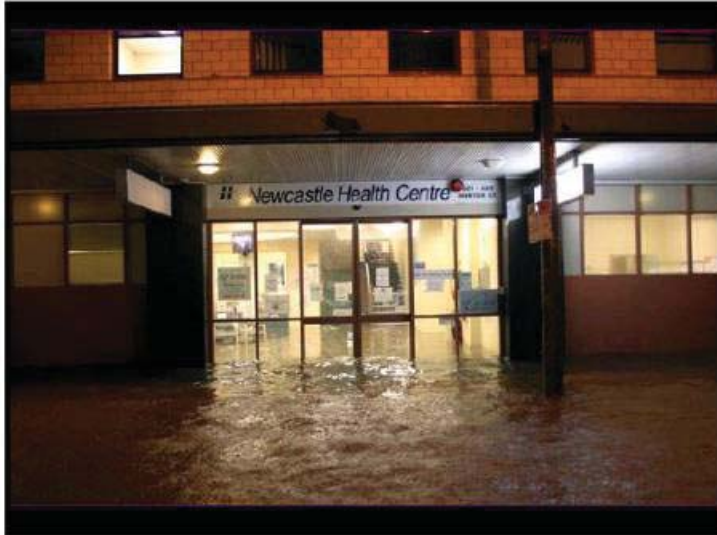
Figure 15 Damage sustained to health facilities during the flash flooding in Newcastle (photo courtesy of NSW Government)
